# CASE HISTORY

## ECP STEEL PIERS™ MODEL PPB-350

### Leaning Grain Silo Restored with ECP Steel Piers™ Garrison, Iowa

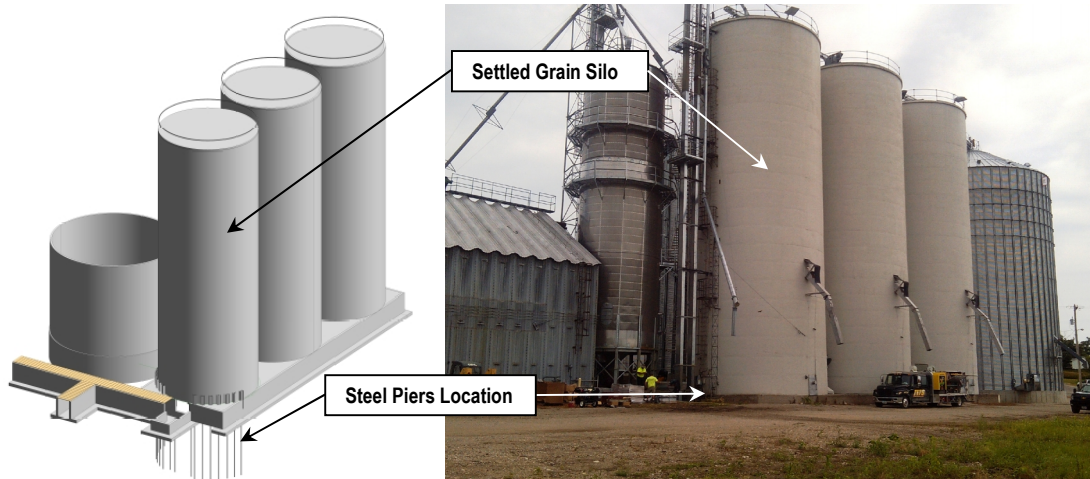
Poor drainage caused softening of the soil underlying the foundation at one side of a 100 foot tall, 30 foot diameter grain silo. The total structural weight of the silo was estimated at 680,000 pounds and the silo has a grain capacity of 1,265 tons. The engineer estimated that the northwest portion of the foundation had settled four inches causing the silo to tilt.

The engineer concluded that the settlement was the result of compromised support under the foundation as a result of moisture intrusion through a crack between the walls and slab. The subsequent freeze and thaw cycles over several years expanded the foundation crack allowing more water intrusion each year, which eventually permitted flow and erosion of the underlying soil. The moisture laden soil under the footing and void under the silo caused the failure of foundation support for a part of the structure. Maximum settlement exceeded four inches.

The engineer recommended deep foundation piles to transfer the structural load from the failing soil under the footing to a suitable load bearing stratum below the surface. ECP Steel Piers™ were selected for rapid repair and restoration of lost elevation with the least disturbance to the weak soil adjacent to the silo foundation. The PPB-350 Steel Pier System uses 3-1/2 inch diameter pier pipe. For additional stability, and to increase the moment of inertia (stiffness) of the steel pier, 4 inch diameter pipe sleeves were installed over the pier pipe. The sleeve joints and the pier joints were staggered to strengthen the coupled joints of the pier system.
