# Case History

ECP Steel Piers™  
Model PPB-350

## Two Grain Silos That Had Settled Were Restored With ECP Steel Piers™ Guernsey, Iowa

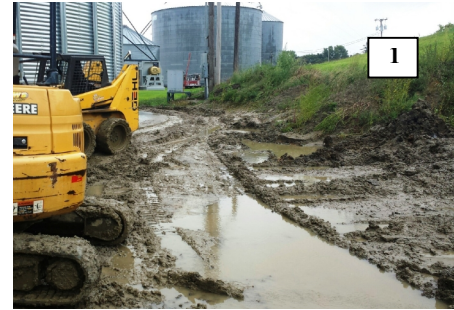
1. Poor drainage and standing water was blamed for the deterioration and loss of soil support under the elevators.
2. The 17 inch thick foundation was cut to allow the ECP Steel Pier™ brackets to be installed under the vertical wall of the elevators. Standing water was encounter in the process confirming the drainage problem on the site.

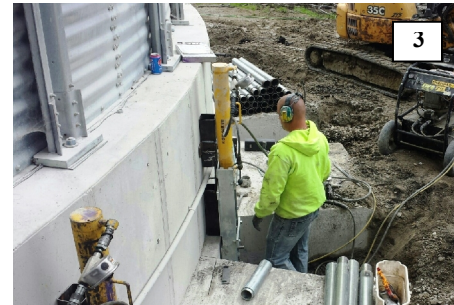
3. The PPB-350 under footing brackets were installed and bolted in place with the bearing plates in contact with the underside of the foundation. A technician is shown advancing the 3-1/2 inch diameter pier pipe into the soil until suitable firm bearing was encountered. Once the bedrock was reached, ranging in depth from 42 to 56 feet, the technician installed 17-1/2 feet of 4 inch diameter sleeve over the pier pipe to stiffen the pier shaft and strengthen the coupled joints. Following the pipe and sleeve installation, the pier pipe was grouted with cement grout. Each pier was then proof tested to an average force of 72,000 pounds to verify the competency of the load bearing stratum deep below the surface.

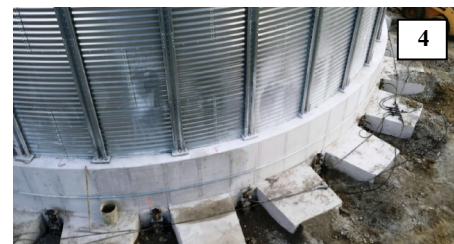
4. Once all of the piers were installed and proof load tested, restoration was accomplished by attaching a lifting assembly to each pier bracket and then placing a 25 ton hydraulic ram between the pier cap on top of the pier pipe and the lift assembly. The hydraulic rams applied an average 42,300 pounds of force simultaneously at each pier placement to recover lost elevation. The lifting force at each placement was monitored with a pressure gauge. Elevation recovery of 1-1/4 inches was achieved at one elevator, and the other elevator foundation was lifted 1 inch.

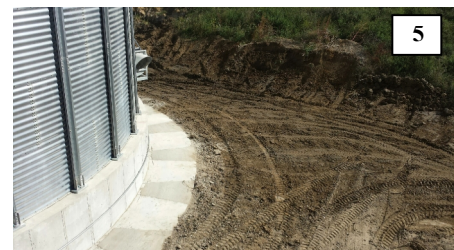
The concrete that was cut and removed for pier bracket access was replaced with new concrete. The disturbed soil in the area of work was replaced and graded for positive drainage. Other drainage improvements insured that the cause of the failure was corrected and the underlying soil was no longer saturated.
