Elastizell

Insulating Concrete Roof Decks

Elastizell Insulating Roof Deck System

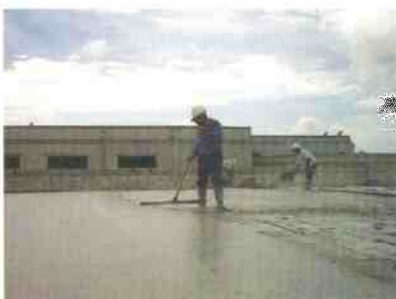
An Elastizell Roof Deck (cast-in-place), provides a slope-to-drain system, plus a strong, permanent roofing base.

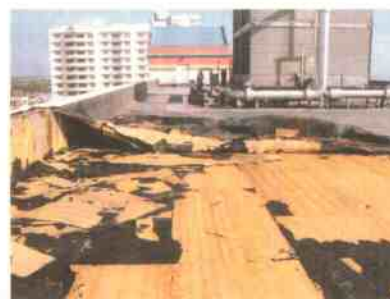
Here is a damaged rigid insulation roof deck system. All of the insulation must be replaced when re-roofing.

When re-roofing over rigid insulation board, the insulation must be replaced. **This is not the case with the Elastizell Insulating Concrete System since only the roofing membrane is replaced.**

In re-roofing applications, Elastizell can be cast over an acceptable, existing membrane still on the roof. Wet insulation material must be removed. When a roofing membrane fails over rigid insulation board, the entire system must be torn off and replaced, since rigid insulation board is damaged by water. The Elastizell Composite System is not damaged by water. **The encapsulated EPS board is completely protected - only the roofing membrane need be replaced.** This significantly reduces the amount of material taken to the landfill, since only a new membrane is installed on the roof.
