Lift Station Rehab

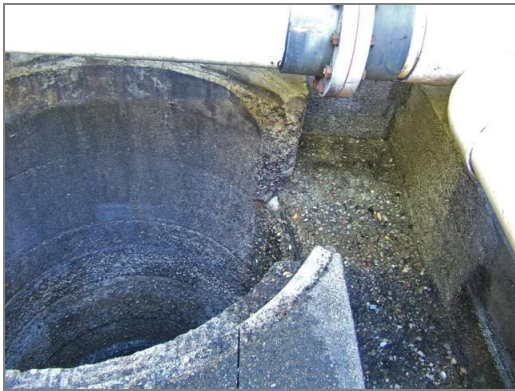
Exposed aggregate, cracking, chipped surfaces and staining are all evident prior to rehab. Hydro-blasting/sand-blasting prepares the surfaces for the cementitious coating.
